### Safe use of ballast brushes

Ref: NRA21-11

Location: Warminster, Wessex Route

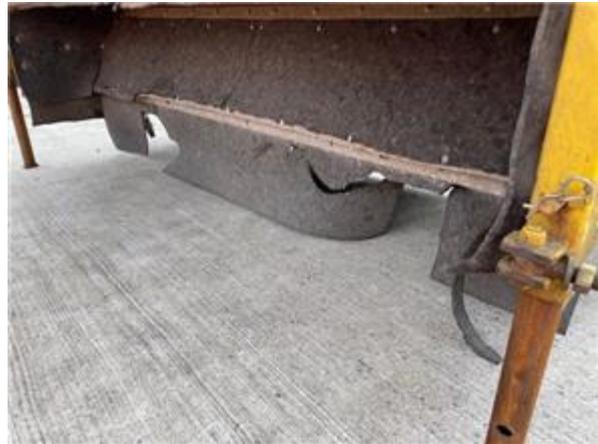
The ballast brush had been maintained by the supplier before delivery to this site, replacing some missing/damaged tines but not the damaged and shortened rubber skirts that are intended to contain ballast during operation.

The ballast brush was being used in deeper ballast and with faster forward speed than designed.

- Pre-delivery and pre-use inspections must be undertaken to ensure that there is no damage to the skirt. Any brushes found to have defective skirts shall be quarantined.

- Ballast brush skirts must provide maximum coverage. Only brushes with a single 3rd rail cut-out can be used in 3rd rail areas. Cut-outs are not allowed for other areas.
